Technical Series 00-138

PERFORMANCE OF A BRICK VENEER/STEEL STUD WALL SYSTEM

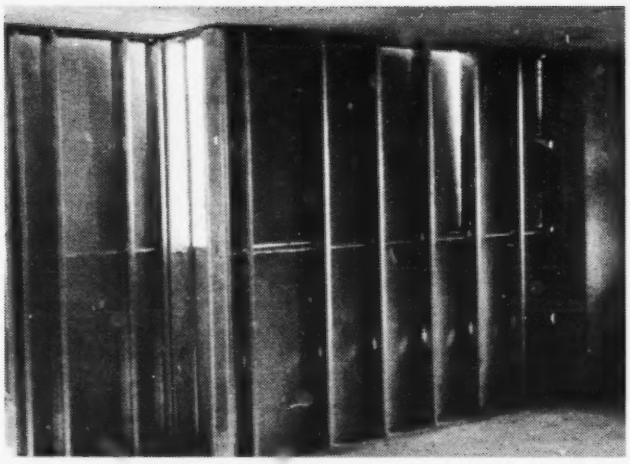
Photograph 1: Framing and Exterior Sheathing
The sheathing is not fastened against the framing yet, but when it is, gaps will remain at the joints that make the sheathing the least air-tight layer in the wall.

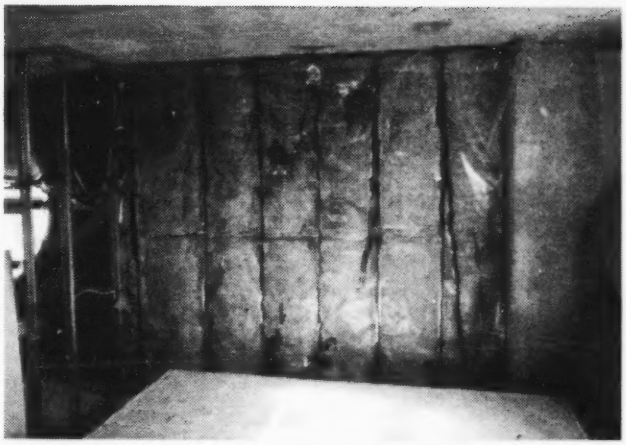
The researchers observed the wall during construction and found that it generally conformed to the design. The workmanship was of above-average quality. Thermocouples, relative humidity sensors, moisture sensors and pressure taps, along with a computer system to collect and record data, were installed. **Photograph 3** shows the wall during construction, with studs, insulation and vapour barrier in place.

Photograph 3: Insulation and Vapour Barrier
The polyethylene vapour barrier is sealed at laps and to adjoining concrete. Electrical outlets have polyethylene back pans, and other penetrations are sealed. For a wall that depends on the vapour barrier to be an air barrier as well, it is reasonably tight.

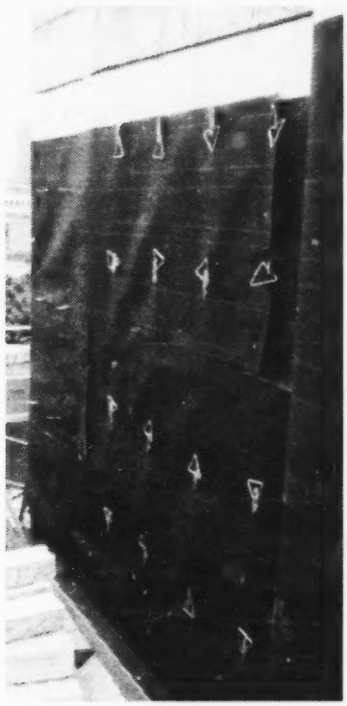
Photograph 2: Sheathing Paper and Masonry Ties
The sheathing paper is lapped to drain, but will not be a barrier to exfiltration. The corner column is insulated on the exterior with rigid extruded polystyrene insulation. At the bottom of the cavity, rigid insulation on the slab edge (covered with paper in this view) extends outward from the plane of the wall, narrowing the cavity at the bottom.

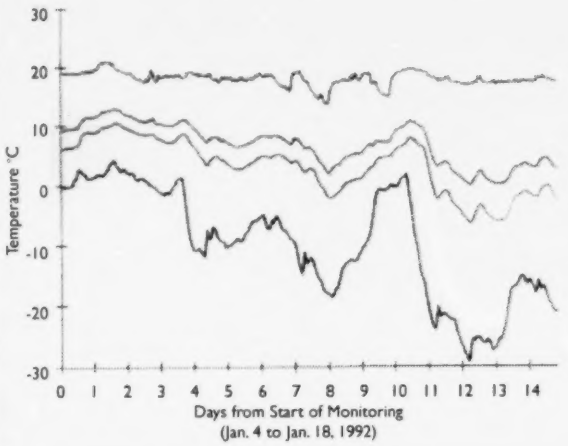
Figure 1: Temperature profile at stud

Thermocouples on stud flanges recorded different temperatures than those located on the corresponding gypsum board surfaces midway between studs. **Figure 1** shows the thermal profile through the wall at a stud, while **Figure 2** shows the profile midway between studs, for the same time period.

The temperature drop across the stud space is larger midway between studs than at a stud. At the stud, the stud space contributes about half of the total temperature difference, while midway between studs it contributes between two thirds and three quarters of the total. Since the thermal resistances of all the other components (air films, drywall, brick, and cavity) are the same in both cases, this is an indication of the extent of thermal bridging.

In -20° C weather the interior surface was as much as 3.5° C colder at the stud locations than midway between studs. Severe dust patterns indicating stud locations (and even drywall screws) were observed after the first year, as can be seen in **Photograph 5**.

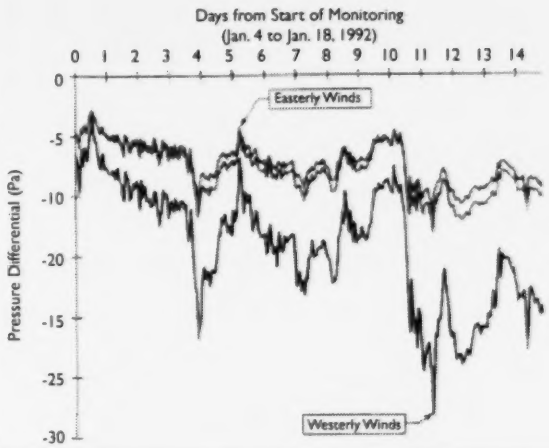
Figure 3: Hourly average pressure differences (before modification of venting)

Pressure taps were located at the exterior, in the cavity, in the stud space, and on the interior. **Figure 3**, typical for winter conditions, shows that the pressure on the interior was usually higher than on the exterior. The pressure difference driving air outward was reduced, but not reversed, by wind toward the wall, and wind away from the wall increased it. The graph also shows that the cavity behind the brick is pressure-moderated, not pressure-equalized. In fact, at least in winter, the cavity at this location was usually at a higher hourly average pressure than if it had been compartmented and pressure-equalized to the exterior. Two significant pressure drops occur, the first from the interior to the stud space, the second across the brick veneer. The relative magnitude varies, but at times the pressure difference across the brick is larger than that across the rest of the wall. Dust left in the insulation, shown in **Photograph 4**, is a further indication of air leakage.

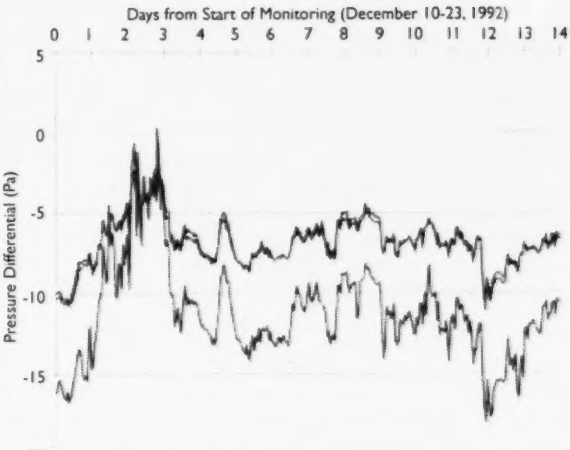
Figure 4: Hourly average pressure differences (after adding cavity vents)

Figure 4 shows that the resistance of the brick veneer remained significant after the addition of vents. The contribution to air flow resistance of the brick was reduced from about a half of the total pressure drop to about a third, while the pressure across the air barrier increased to about two thirds. (Note that 0 Pa is not at the top of the graph, as it is in Figure 3). Because flow increases exponentially with pressure difference, with the same equivalent leakage area of the interior air barrier, adding the vents presumably caused an increase in air leakage.

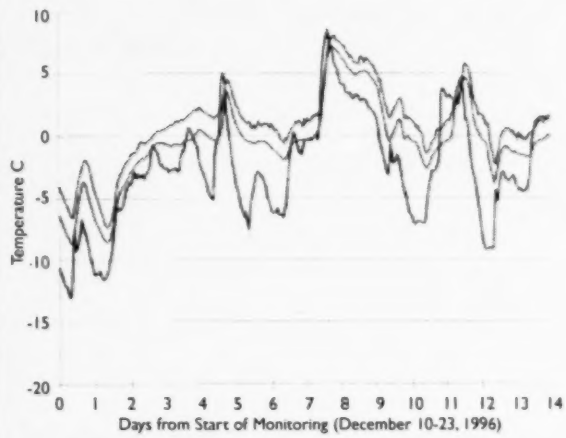
Figure 5: Temperatures of interior brick face, cavity dewpoint, and exterior air

As a result of air leakage primarily, condensation occurred on the inner surface of the brick veneer almost all of the time during late fall and winter. **Figure 5** shows the surface temperature at the back of the veneer, in relation to the dewpoint temperature of the air in the cavity and the exterior air temperature. During the period shown, the brick surface temperature was constantly below the dewpoint temperature, indicating that condensation was occurring. Even when exterior air

temperature rose above the cavity dewpoint (when a period of drying might be expected), although the cavity dewpoint temperature rose, the brick remained colder.

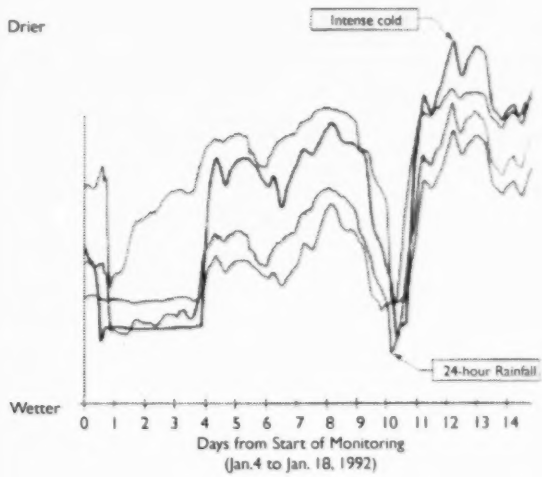
Figure 6: Relative wetness of brickwork

Moisture sensors revealed that in fall, winter, and spring the interior face of the brick was relatively wet, much more so than the exterior. When it rained, the exterior surface rapidly became wet, but dried soon after. Until the vents were added at the top of the cavity, rain penetration performance was satisfactory (after they were added the vents allowed more rain to enter the cavity). Although the wall seemed well constructed and relatively airtight, moisture problems were mainly caused by air leakage. **Figure 6** shows, in relative terms, the amounts of moisture in the brickwork, at inside and exterior faces, for locations near the roof slab, and at

the floor level. In order to interpret this graph, remember that when moisture freezes, the sensor reports a false dry condition. This possibility can be judged by reading the exterior temperature, or the sheathing temperature, depending on which surface of the brick is of interest, from **Figure 2**.

The cavity did not dry out in cold weather because more moisture condensed from leaking interior air than was removed by evaporation and venting. Throughout the winter season, when freeze-thaw cycling occurred, the back of the brick remained wet. Adding vent holes allowed more moisture to enter the cavity, and did not improve drying. The brick was not uniformly wet—the cavity and the back of the brick dried out only in the summer and were wet for the rest of the year, while the exterior face was drier.

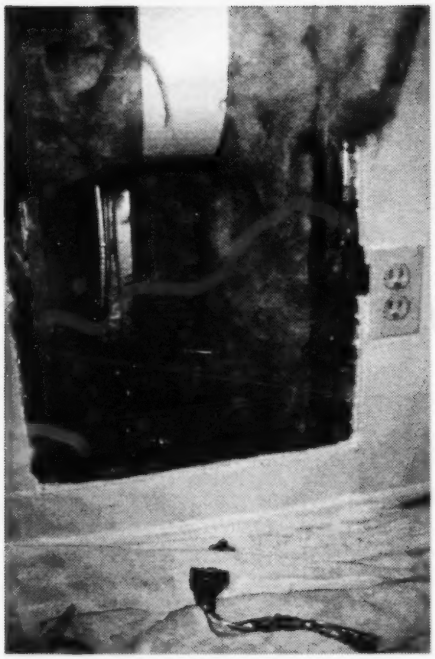
Photograph 4: Dust Staining of Insulation
Evidence of air leakage: dust left behind in the insulation.

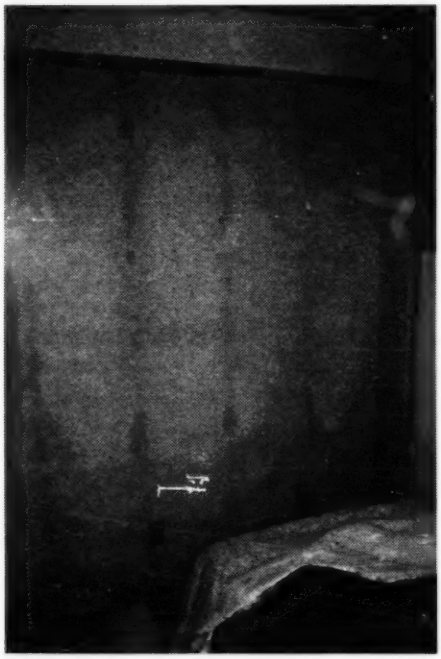
Photograph 5: Dust Staining at Stud Locations
Thermal bridging: indoor surfaces at stud locations are colder in winter than the surfaces between studs. More dust is attracted to the cooler surfaces, resulting in the staining seen here.

- Insulation on the exterior, in the cavity, sufficient to keep the gypsum sheathing above the interior air dewpoint temperature (this will also reduce thermal bridging of framing).
- Better airtightness, to reduce latent heat loss and reduce condensation in brickwork.
- A larger minimum cavity depth, to promote drainage and drying.
- Better venting of the cavity (arranged to exclude rain).

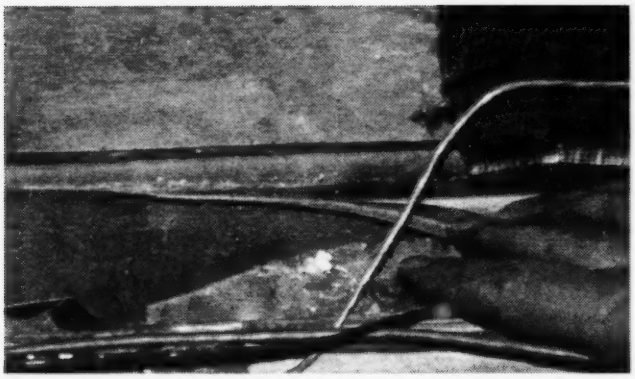
The corresponding situation was similar for the back of the sheathing and the dewpoint temperature of the air in the stud space. While the coldest part of the stud, the exterior flange, was always warmer than the dewpoint temperature of the air in the stud space, the inside face of the sheathing midway between studs was consistently below dewpoint temperature. The mold seen on the back of the sheathing after a year, shown in **Photograph 6**, is further evidence.

Photograph 6: Mildew or Mold on Interior Surfaces of Exterior Sheathing
When the wall was opened, this staining was visible on the interior side of the exterior sheathing—here at mid-height, and to a greater extent at the base of the wall.

- There was no frost or surface moisture on the brick, which appeared fairly dry.
- The building paper and exterior sheathing were very wet and significant amounts of mildew were observed on the interior side of the sheathing, especially at the bottom.
- The insulation in contact with the exterior sheathing was wet.
- Corrosion of the framing was minor. The bottom track showed zinc oxidation (white rust) and signs of periodic wetting. Otherwise, there was rust only on cut edges, screw tips and shavings.
